THE NEW NORMAL – OPERATING AND MAINTAINING THE MALLARD CREEK WATER RECLAMATION FACILITY AFTER A PCB CONTAMINATION

Maggie Macomber¹, Darrell DeWitt², Jonathan Lapsley, PE³, Roger Smith, PG⁴

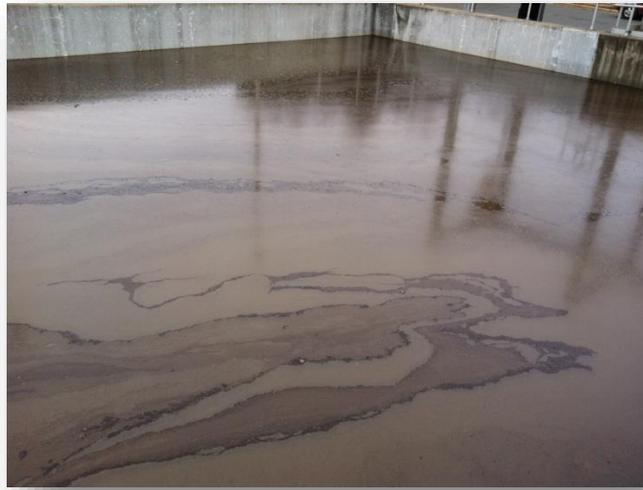
Figure 1: PCB Contamination in Day Tank

In 2013, several collection systems and resource recovery facilities in South Carolina located along the Interstate 85 corridor were contaminated by illicit discharges containing PCBs. On February 6, 2014, a plant operator at the MCWRF noticed an unusual and very strong chemical smell. Upon further investigation, the plant staff detected an oily substance in several unit processes including the headworks, the diurnal flow control structure called the day tank, and the primary clarifiers. The sheen on the day tank is shown in Figure 1. Samples of the substance

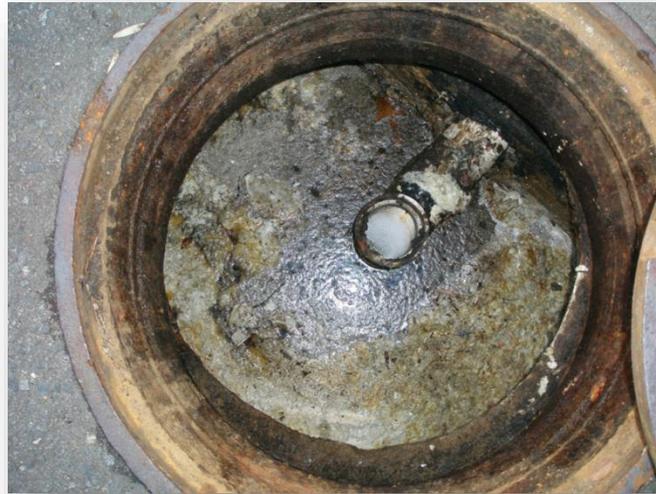
Figure 3: Contaminated Grease Trap

with no signs of letting up. Crews investigated the collection system on foot and in trucks and finally found a grease trap at a local grocery store where the substance was discharged to the collection system. The contaminated grease trap is shown in Figure 3. The contamination traveled through approximately 14 kilometers (8.7 miles) of pipeline and 181 manholes to the MCWRF. While PCBs are odorless, another chemical in the oil substance called trichlorobenzene has a strong diesel-like odor which helped the crews track the contamination through the system.

Samples taken from the grease trap revealed that the PCB concentration had significantly exceeded 50 ppm. The limits of contamination included the collection system from the grease trap connection to MCWRF and most unit processes within MCWRF. The grocery store was responsible for dealing with the contamination of their grease trap. Analytical results from the grease trap sampling are shown in Table 1.
