SWIMMING IN SUCCESS, NOT I/I – WHAT MADE IT WORK – CLEVELAND, TENNESSEE’S SCOPE 10 PROGRAM

Travis E. Wilson, PE ¹, Greg Clark, PE ²
twilson@smeinc.com

¹ S&ME, Inc., Murfreesboro, Tennessee

² Cleveland Utilities, Cleveland, Tennessee

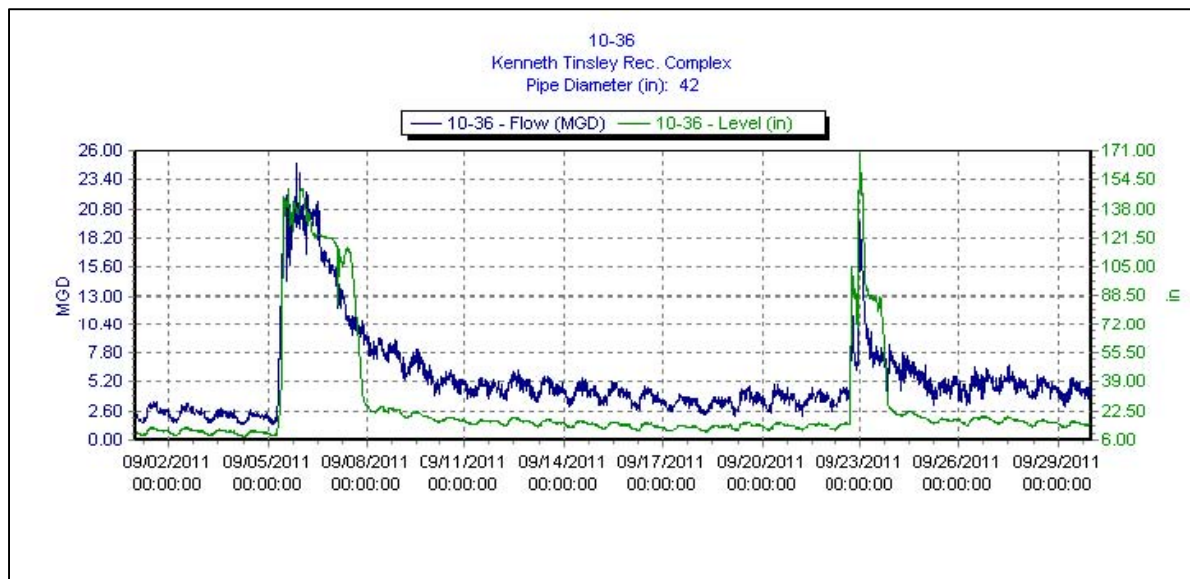
Figure 2 – Depth-Flow Hydrograph – Basin 10-36

The results from the 2011 study indicated that approximately 53% (11.3 MG during the initial 24-hour storm period) of the rain-dependent inflow and infiltration (RDII) volume was observed within approximately 27% (360,000 LF) of the monitored area. These areas were identified as Basins 31-45 and 10-36. Both metering locations indicated significant inflow and infiltration signatures in the data with sustained peaks of 22 MGD, a 120% increase from average daily flow.

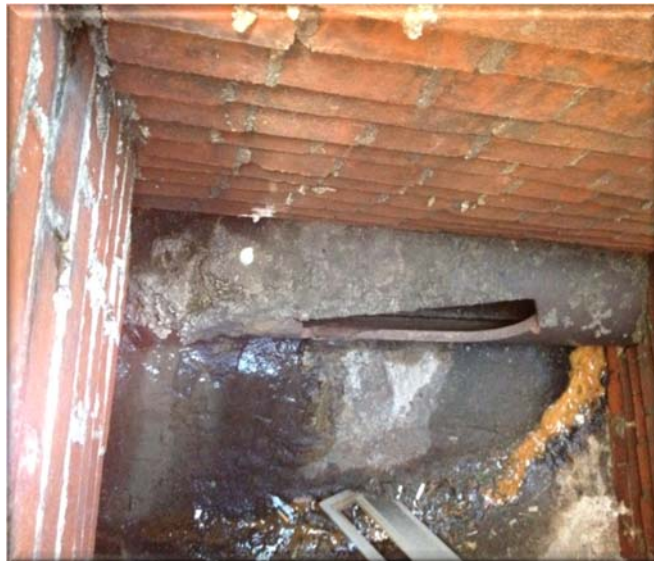
Figure 5 – Broken 8-inch Sewer Mainline in Storm Catch Basin

Smoke Testing - As indicated in the table, smoke testing was performed in the driest season of the year and typically completed prior to the manhole inspections. This allowed for the location of manholes along heavily vegetative easement areas. Smoke testing was also a quick and efficient means to locate potential cross-connection leaks that allow high volumes of I/I into the sewer system. Typically, because smoke testing is an economical means to locate defects, all pipeline segments with diameters 6-inch to 15-inch are completed. In Figure 5, a sewer mainline pipe was found defective running through a storm catch basin during smoke testing.

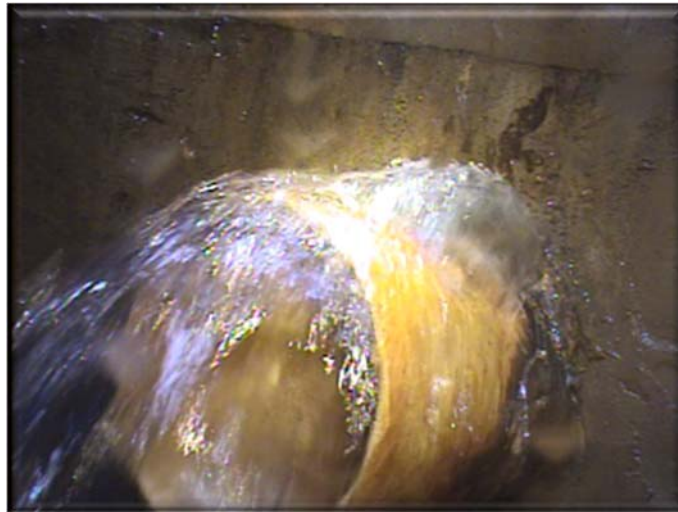
Figure 6 – Active Infiltration at Manhole/Line Connection

Manhole Inspections – The completion of manhole inspections is crucial in obtaining an inventory of the system, verifying connectivity, and identifying inflow sources. Each manhole is located and inspected as part of this process. In order to maximize funding, inspections are scheduled during wet weather periods or periods of high ground water such that defects might be observed, logged, and prioritized for repair. Figure 6 is an example of a significant defect found during wet weather manhole inspections.

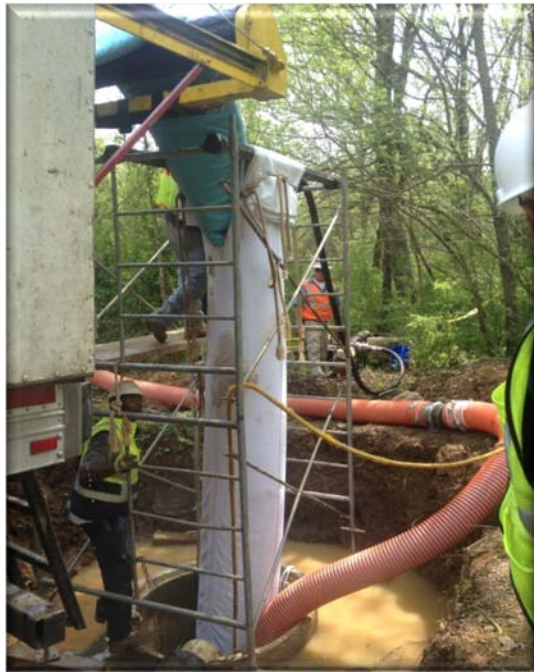
Figure 11 – CIPP Mainline Repair

Where possible, trenchless rehabilitation methods were recommended to minimize public disturbance as much of the work was located under the pavement of City streets. Cured-in-place pipe (CIPP) was installed to repair defective mainlines (See Figure 11) along with pipe bursting techniques; however, some open-cut-replacement was necessary in certain applications. In lieu of replacement, manholes were rehabilitated utilizing a spray on coating to provide both structural and corrosion resistant protection (see Figure 12).

A key component of these projects was the comprehensive repair methodology utilized. On all mainline repairs utilizing CIPP technology, each lateral along that line was also repaired either by installing a CIPP lateral liner or by open-cut-replacement methods (i.e., installing a saddle at the connection and new PVC pipe back to the property line). The manholes on either side of the line segment were also repaired by spraying a polyurea or epoxy based liner to prevent corrosion and seal the manhole walls and manhole/line connection, thus preventing I/I from migrating through the pipe trench to the manhole.

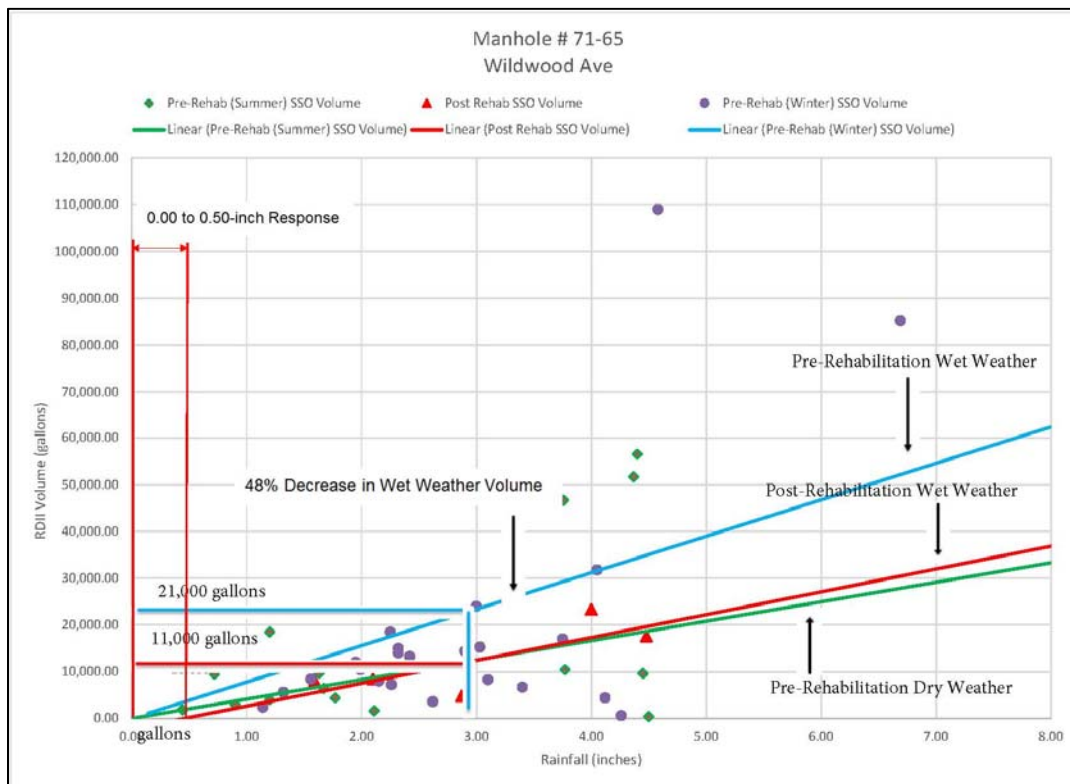
Figure 15 – Q vs i Comparison – Pre/Post Rehabilitation Wildwood Ave

As illustrated in Figure 15, a 48% decrease in wet weather rain dependent I/I (RDII) volume was observed as a result of the rehabilitation work completed. Pre-rehabilitation wet weather volume for a 3-inch rain event resulted in approximately 21,000 gallons of RDII during the initial 24-hour storm period. Post rehabilitation wet weather RDII volume was reduced to approximately 11,000 gallons of RDII. Additionally, during pre-rehabilitation conditions, only a trace of rainfall resulted in an increase of flow, while post rehabilitation results indicated 0.50-inches of rainfall was required to produce any type of reaction within the system. The result was achieved by primarily addressing lateral connection of previously lined mainlines and the rehabilitation of leaking manholes.

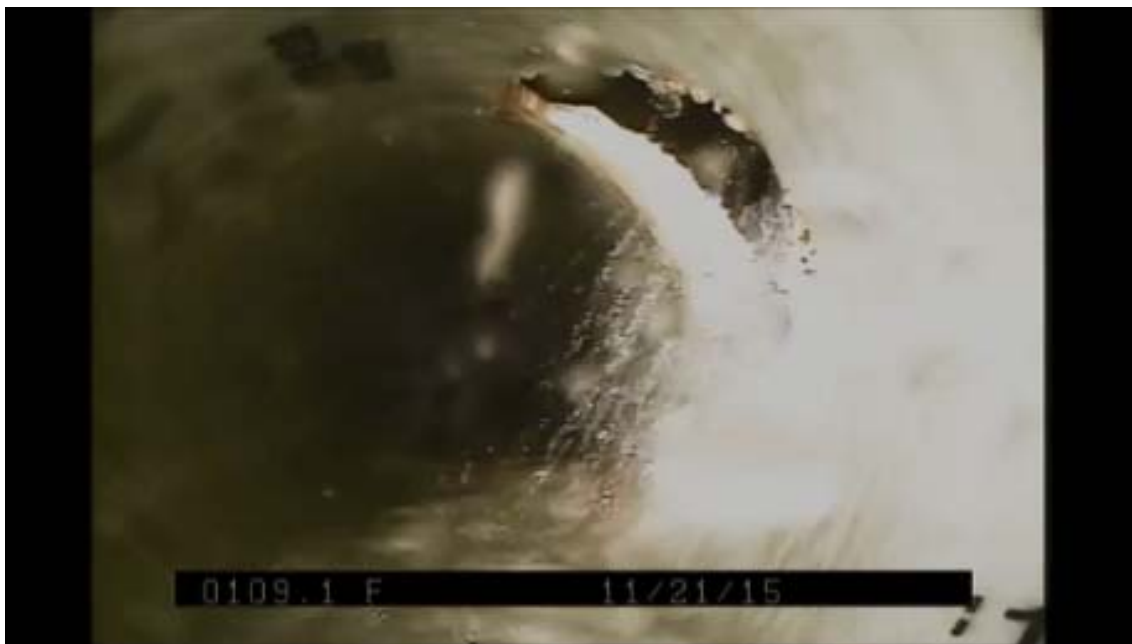
Figure 21 – Leaking Service Connection – Core & Brushed Only

With the work completed to-date, there have been great successes measured both on a large scale and on a small scale in more localized areas. There are some key factors to which the successes are greatly attributed, with the most important being **adaptability**. Although a plan was formulated prior to the initial project, Cleveland Utilities and S&ME staff worked closely throughout the process to evaluate each step of the project, both during and after completion, to determine what worked well and what needed to be revised. For example, in the initial project, on mainlines where CIPP was installed, only those service lateral connections that were observed (from the mainline) to be defective were repaired. Those connections that were PVC saddles were only cored and brushed. However, as illustrated in Figure 21, I/I migrated to the service connections that had only been cored and brushed, entering the mainline between the CIPP and host pipe material. Although the original PVC saddle connection may have been in satisfactory condition, this did not provide a complete seal.

Additionally, on earlier projects, no laterals were televised unless they were being rehabilitated via CIPP liner; however, this resulted in a significant number of contract changes due to the unknown condition of the laterals, including the ability to be rehabilitated via trenchless methods. On current SSES projects, all laterals along priority mainlines (as determined through the flow isolation process) are being televised. The advantage is that an early assessment of each lateral can be made during the design of the rehabilitation project, and not on-the-fly during the construction process. This provides more stability during the construction phase. Consequently, pricing for the lateral CCTV inspection is approximately 3.5-4.0 times cheaper when performed in bulk during the SSES phase.

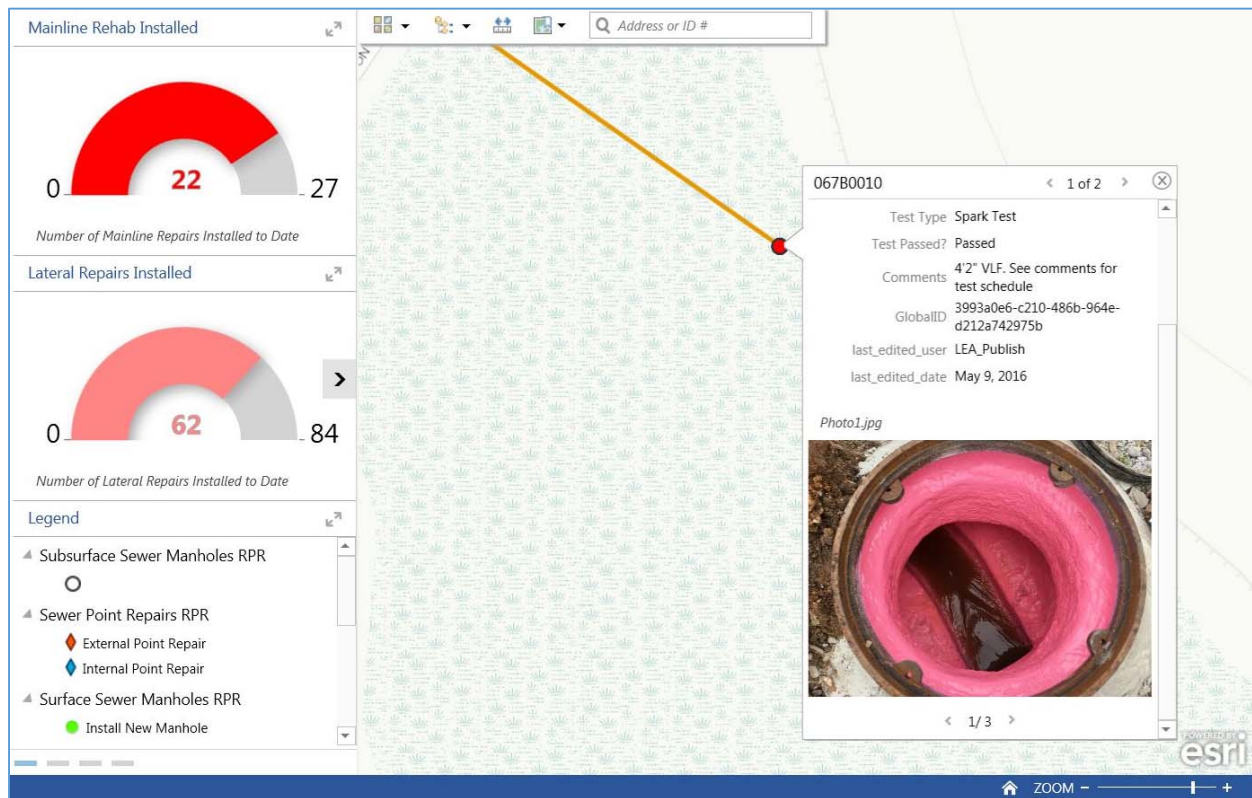
Figure 22 – RPR Construction Application

Another key contributing factor in the success of the rehabilitation program is the **continuous oversight during the construction phase**. The best designs are only successful with proper construction. With so many varying types of repairs and as many different sub-contractors on one project, continuous oversight to ensure the specifications are being followed is crucial to success. Trenchless rehabilitation repairs are typically considered specialized work with a limited number of contractors available. With project requirements changing in each City a contractor performs works, it is imperative to hold meetings throughout the construction phase discussing details of the project. Cleveland Utilities provided trained resident project representatives (RPR) throughout each project with assistance from S&ME. Having trained representatives on site continuously facilitates a smooth flow of work as they are able to answer questions, address concerns, and oversee the product going into the ground. In order to help with organization of documentation coming in from the field, on current projects, RPRs are using ArcGIS products on iPads to document all work performed. This includes photos, comments, and sign-off sheets, all which provide a means to track the project in real-time through ArcGIS (see Figure 22).
